## CASE STUDY

# Concrete Roof Slab Waterproofing

Zenith Bank Head Office, Ajose Adeogun, VI, Lagos

Roof Slab Repair & Protection

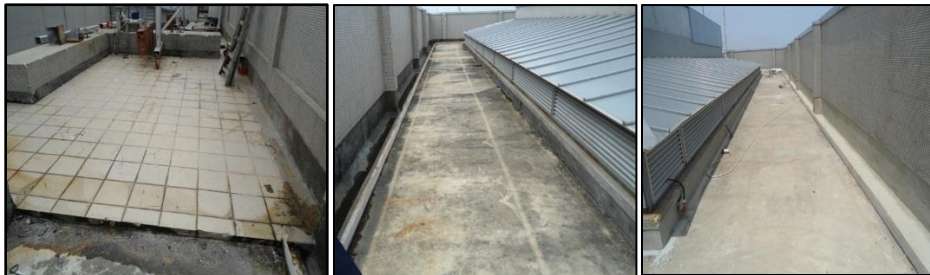
The concrete slab was reported to be leaking on the roof slab floor, despite the presence and the use of Bituminous Felt Membrane protection. The leakages were most evident in the penthouse floor where the Board Room and Top Management of the Bank offices are located.

The Concrete Logistics team were contacted to provide a permanent waterproofing solution for the roof slab. The solution provided by the team include removal of existing tiles and the damaged felt membrane, specialized surface preparations and surface treatment using Krystol T1/T2 waterproofing systems. Also the entire joints between the internal walls and floors were fixed using Krystol crack/joint repair systems to render these areas watertight, while pipe penetration points were treated using the dedicated Krystol pipe penetration system. This treatment is guaranteed to last the entire life of the concrete, which means no other forms of waterproofing (including bituminous felt) is required throughout the life of the concrete slab.
