## CASE STUDY

# Leaking Underground Septic Tanks of a Private Building

Trans Area, Port-Harcourt

Leaking Underground Septic Tank

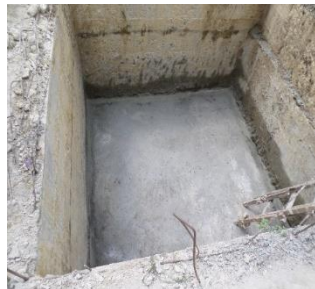
It was observed that the septic concrete base floor and walls were cast separately having joint created at the base of tank between the floor/walls which is a major source of leakage. Honeycomb formed part of the concrete which are major weakspots for leakage. The entire septic tank floor base is observed to be porous and seeps in water

**While working on affected areas**

This will include hacking off the plaster and screed to reveal concrete surface to be treated. Our Krystol Joint repair Treatment was applied on the base joint between floor and walls. Following this, our Krystol Pipe Penetration and Weakspot Treatments. The KMA Treatment was used on the length of partition walls inside the tank. To finish off, the Krystol T1/T2 Treatment was applied on all the surfaces. Combined these will render the leakage prone areas watertight.
