CASE STUDY

WATERPROOFING TREATMENT OF DAMPED WALLS

Surulere, Lagos

Rising Damp

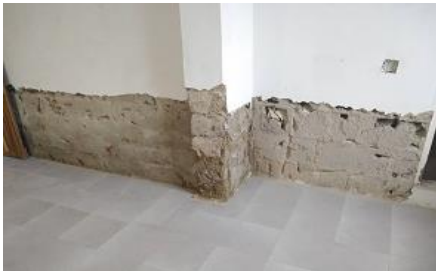
Removal and disposal of plaster

The solution provided by the team include removal of the surface area of the existing failed plasters on the walls will be treated using our Krystol Mortar Admixture (KMA) to be used for the plastering after the treatment has been done. This treatment is guaranteed to last the entire life of the concrete, which means no other forms of waterproofing is required throughout the life of the concrete. This will render these areas water tight.

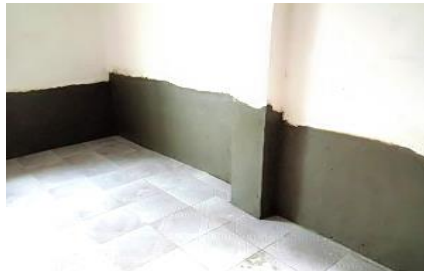
Re-plastering With KMA Treatment
