CASE STUDY

SQUASH COURT BASEMENT WATERPROOFING

Pier Harbour Apartment, Victoria Island

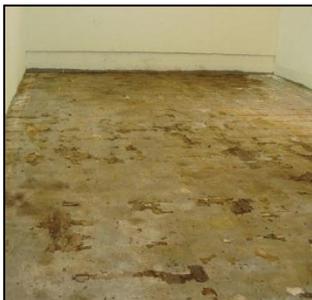
The issue of water seepages from floor slabs and wall joints were major threats to the functionality and utilization of this luxury basement used as squash court at Victoria Island, Lagos. Due to the high water table and hydrostatic pressure within the area, there were obvious signs of water seepage from below grade slab with water seeping out of the joints in the court. There were also several cracks on the concrete floor surface. Several surface waterproofing membranes had been employed in the past but all failed with great damage done to the wooden squash court floor tiles.

**Damaged Basement
due to Rising Damp**

To permanently solve this problem, Krystol Integral Concrete Waterproofing systems were adopted. Having removed the damaged wooden tiles, the concrete slab was exposed prior to the Krystol waterproofing treatment. The cracks and joints were diligently treated by the Concrete Logistics team prior to the application of Krystol T1/T2

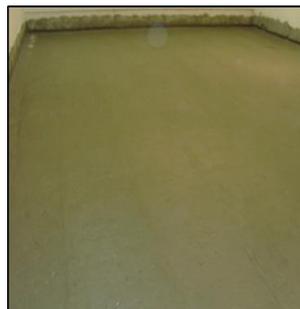
**Krystol Treated Basement
Squash Surface**
