CASE STUDY

WATERPROOFING OF BATHROOMS

IKOYI

WET AREAS WATERPROOFING

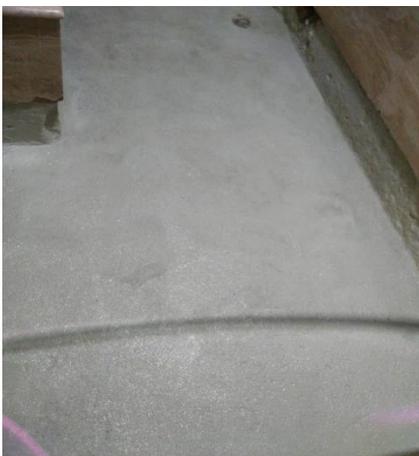
Application of Hydro Ban

The tiles in the bathrooms were removed, to get to the concrete beneath, prior to the application of the Krystol Pipe Penetration treatment. Two coats of Laticrete Hydro Ban were applied (first coat is applied and cured, then the second coat is applied) after the leakage around the pipe penetration was curbed using the pipe penetration treatment.

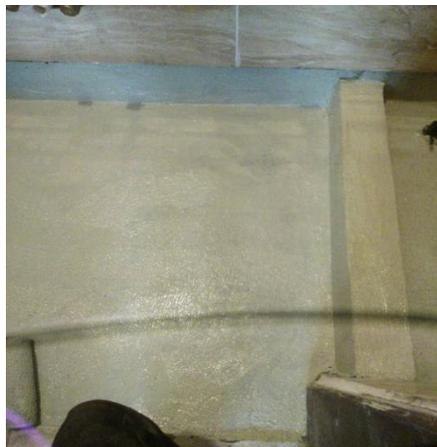
Hydro Ban after curing
