CASE STUDY

UNDERGROUND WATER TANK REPAIRS

Centre of Excellence, UNEC, Enugu, Nigeria 2013

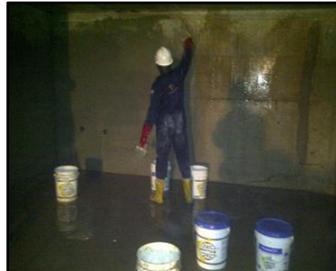
Underground tank during treatment

Firstly, the tank floor, wall and soffit were carefully prepared for treatment and treated with Krystol T1/T2 Surface Application Treatment, while all the observed concrete cracks and weak spots were treated with Krystol Crack Repair System to render the surface waterproofed.

Also, the joints were treated using Krystol Joint Repair System to make these areas watertight

Specialized Pipe penetration treatment around the pipes for water inlets/outlets was carried out.
