CASE STUDY

Waterproofing of an Overhead Water Tank Slab & Damp Walls

Ikoyi, Lagos

Overhead Water Tank Slab & Damp Walls

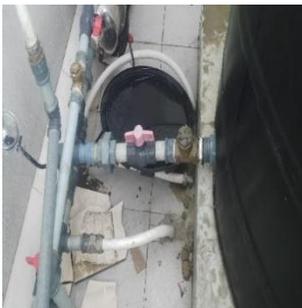
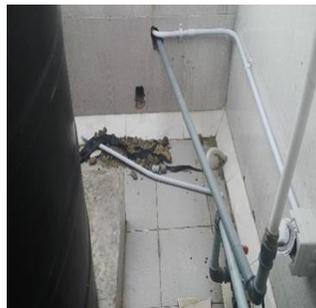
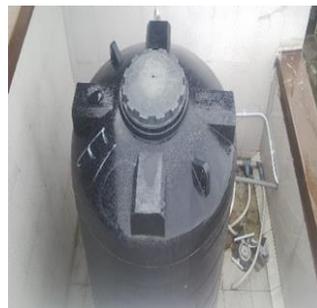
It was observed that the water seeps through the joints between parapet/building walls and floor slab to dampen the soffit of the slab. Water also seeps through the floor slab itself and portions of the tiled walls including the buried pipes in the slab to stain the ceiling. The water stains at the soffit of the first floor dining area was suspected to be a faulty plumbing pipe in the bathroom above, while the dampness in the ground floor guest room is by rise of ground water through capillary's action and also faulty plumbing pipe in the external wall.

Concrete Logistics Limited was invited to provide and install Krystol Crystalline waterproofing Systems. After the assessment, the floor tiles and underlying screed/felt will be removed to expose the concrete slab for treatment after the water tank has been disconnected and removed from the work area. The joint between the walls & slab was treated using our Krystol Joint Repair System & Krystol T1/T2 Surface Applied Treatment. The drain Pipe & other pipes buried in the floor slab was made watertight using our Specialized Krystol Pipe Penetration Treatment before the previously removed screed was replaced with cement-sand (1:4) mortar dosed with our Krystol Mortar Admixture to make it watertight.

- Krystol T1/T2 Systems
- Krystol Joint Repair System
- Krystol Pipe Penetration
- Krystol Mortar Admixture (KMA)
