CASE STUDY

# WATERPROOFING OF ROOF TERRACES

Banana Island, Ikoyi, 2024

Leaking Roof Terraces

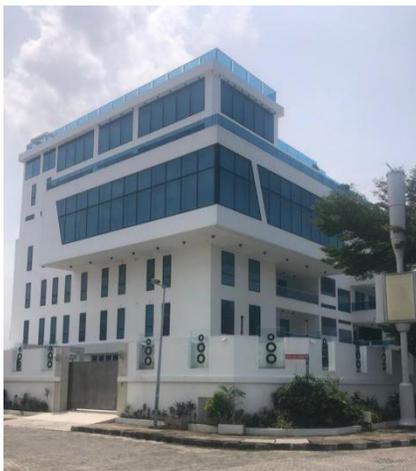
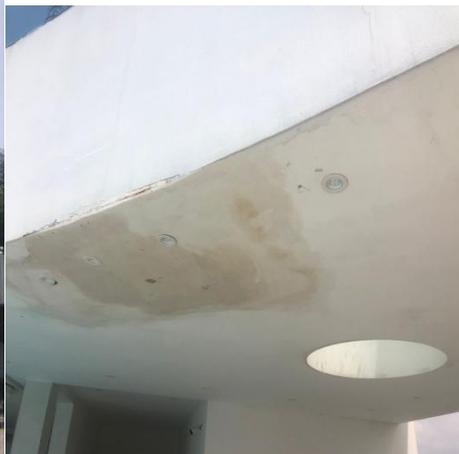
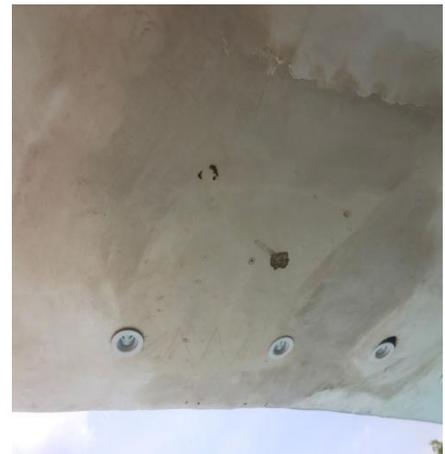
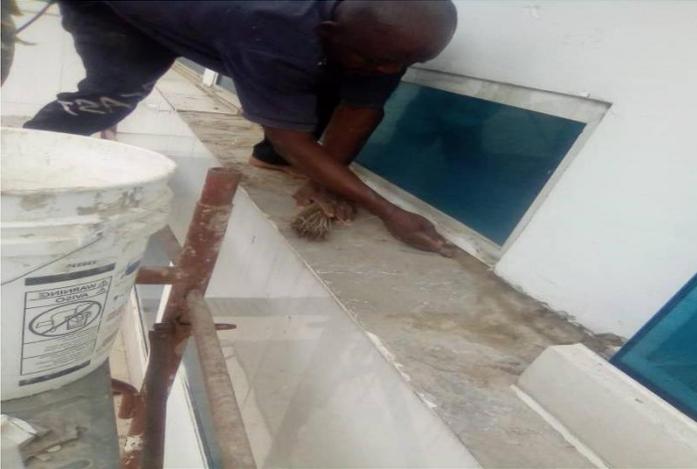
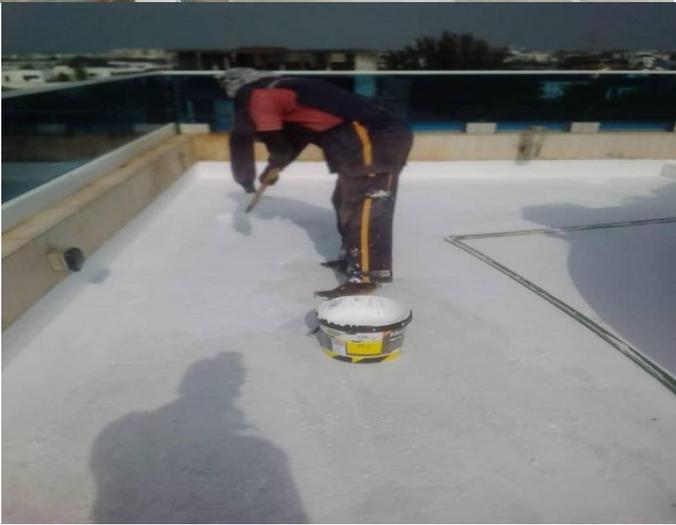
Water ingress was significantly observed along the linear joint of the roof terrace, indicating failed waterproofing. Multiple cracks and weak spots were also visible on the terrace surface, which are potential points of water entry during rain. Visible signs of deterioration on the membrane felt and screed layers are likely contributing to the leakage problems.

The team's solution started from removal of existing felt membrane, garden and the existing screed. Then surface preparation and treatment was carried out using our specialized Krystol T1/T2 waterproofing systems. The entire joints were fixed using Krystol crack/joint repair systems to keep the areas watertight.

Finally, Krystol Mortar Admixture(KMA) was used to re-screed the treated areas and Bauer Aquasil for floor areas
