CASE STUDY

Access Bank Head Office

Victoria Island, Lagos

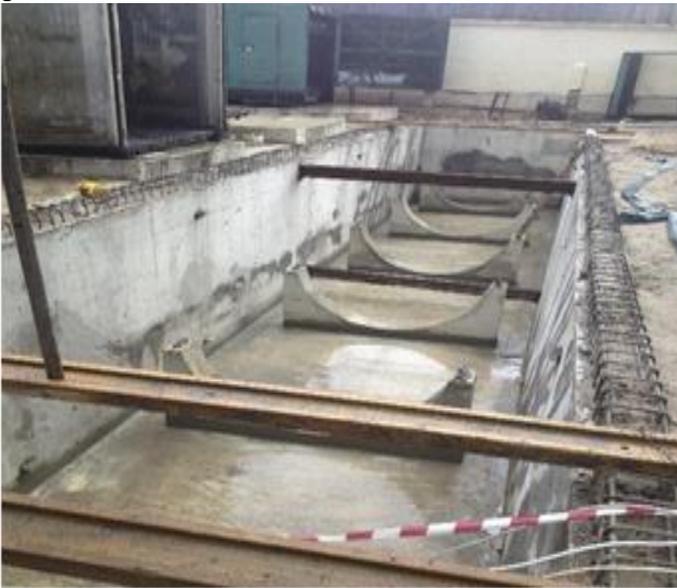
Building prior to waterproofing with Kryton's Krystol Internal Membrane (KIM)

Kryton's KIM being known for its permanent waterproofing ability was opted for. The concrete diesel tank encasement was dosed with KIM to make it watertight and also guard against corrosion of structural steel from the salt contaminated ground water.
