CASE STUDY

# REPAIRS AND WATERPROOFING OF WASTE WATER TREATMENT PLANT

Golden Sugar, Flour Mills, Apapa

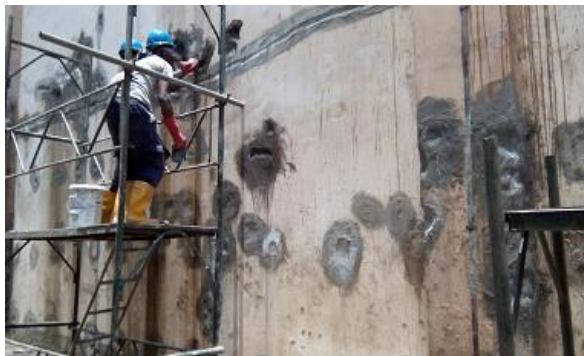
Repairs and Waterproofing Work in Progress

After the assessment the existing wall plaster was removed to expose the concrete surface for treatment. All cracks/joints were repaired using our Krystol Joint/Crack Repair System. All surfaces were then treated with Krystol T1/T2 Surface Applied Treatment. Weakspots and other concrete defects in the concrete were repaired with Krystol Bari-Cote and Plasti-Patch. Final treatment was cement-sand (1:4) mortar dosed with our Krystol Mortar Admixture to make the plant watertight.
