REPAIRS AND WATERPROOFING OF WASTE WATER TREATMENT PLANT

Golden Sugar, Flour Mills, Apapa

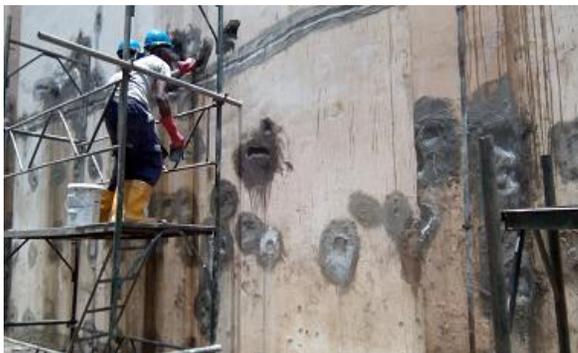
Repairs and Waterproofing Work in Progress

After the assessment the existing wall plaster was removed to expose the concrete surface for treatment. All cracks/joints were repaired using our Krystol Joint/Crack Repair System. All surfaces were then treated with Krystol T1/T2 Surface Applied Treatment. Weakspots and other concrete defects in the concrete were repaired with Krystol Bari-Cote and Plasti-Patch. Final treatment was cement-sand (1:4) mortar dosed with our Krystol Mortar Admixture to make the plant watertight.
