WATERPROOFING TREATMENT OF DAMPED WALLS

Surulere, Lagos

Rising Damp

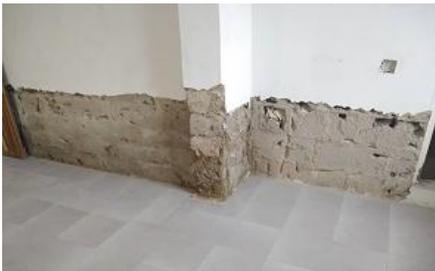
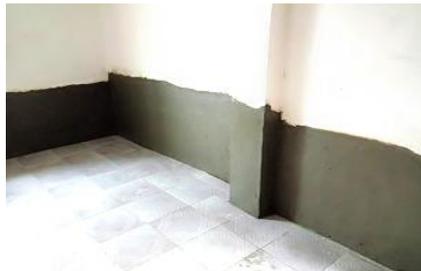
Concrete Logistics Limited was asked by the client to assess the general condition of the building and find waterproofing solution to it. Upon visual observation, it was realized that the walls of the bedrooms and corridor were damp and as a result, the paint and plaster on the walls were flaking off. The dampness of the walls is attributed to rising moisture caused by the higher water table nature in the areas

The solution provided by the team include removal of the surface area of the existing failed plasters on the walls will be treated using our Krystol Mortar Admixture (KMA) to be used for the plastering after the treatment has been done. This treatment is guaranteed to last the entire life of the concrete, which means no other forms of waterproofing is required throughout the life of the concrete. This will render these areas water tight.
